NEW DRESSER NO. 4 DAM  
WASHINGTON COUNTY, MISSOURI  
MO 31124

**PHASE I INSPECTION REPORT  
NATIONAL DAM SAFETY PROGRAM**

NEW DRESSER NO. 4 DAM  
WASHINGTON COUNTY, MISSOURI

PREPARED BY  
INTERNATIONAL ENGINEERING COMPANY, INC.  
CONSULTING ENGINEERS  
SAN FRANCISCO, CALIFORNIA

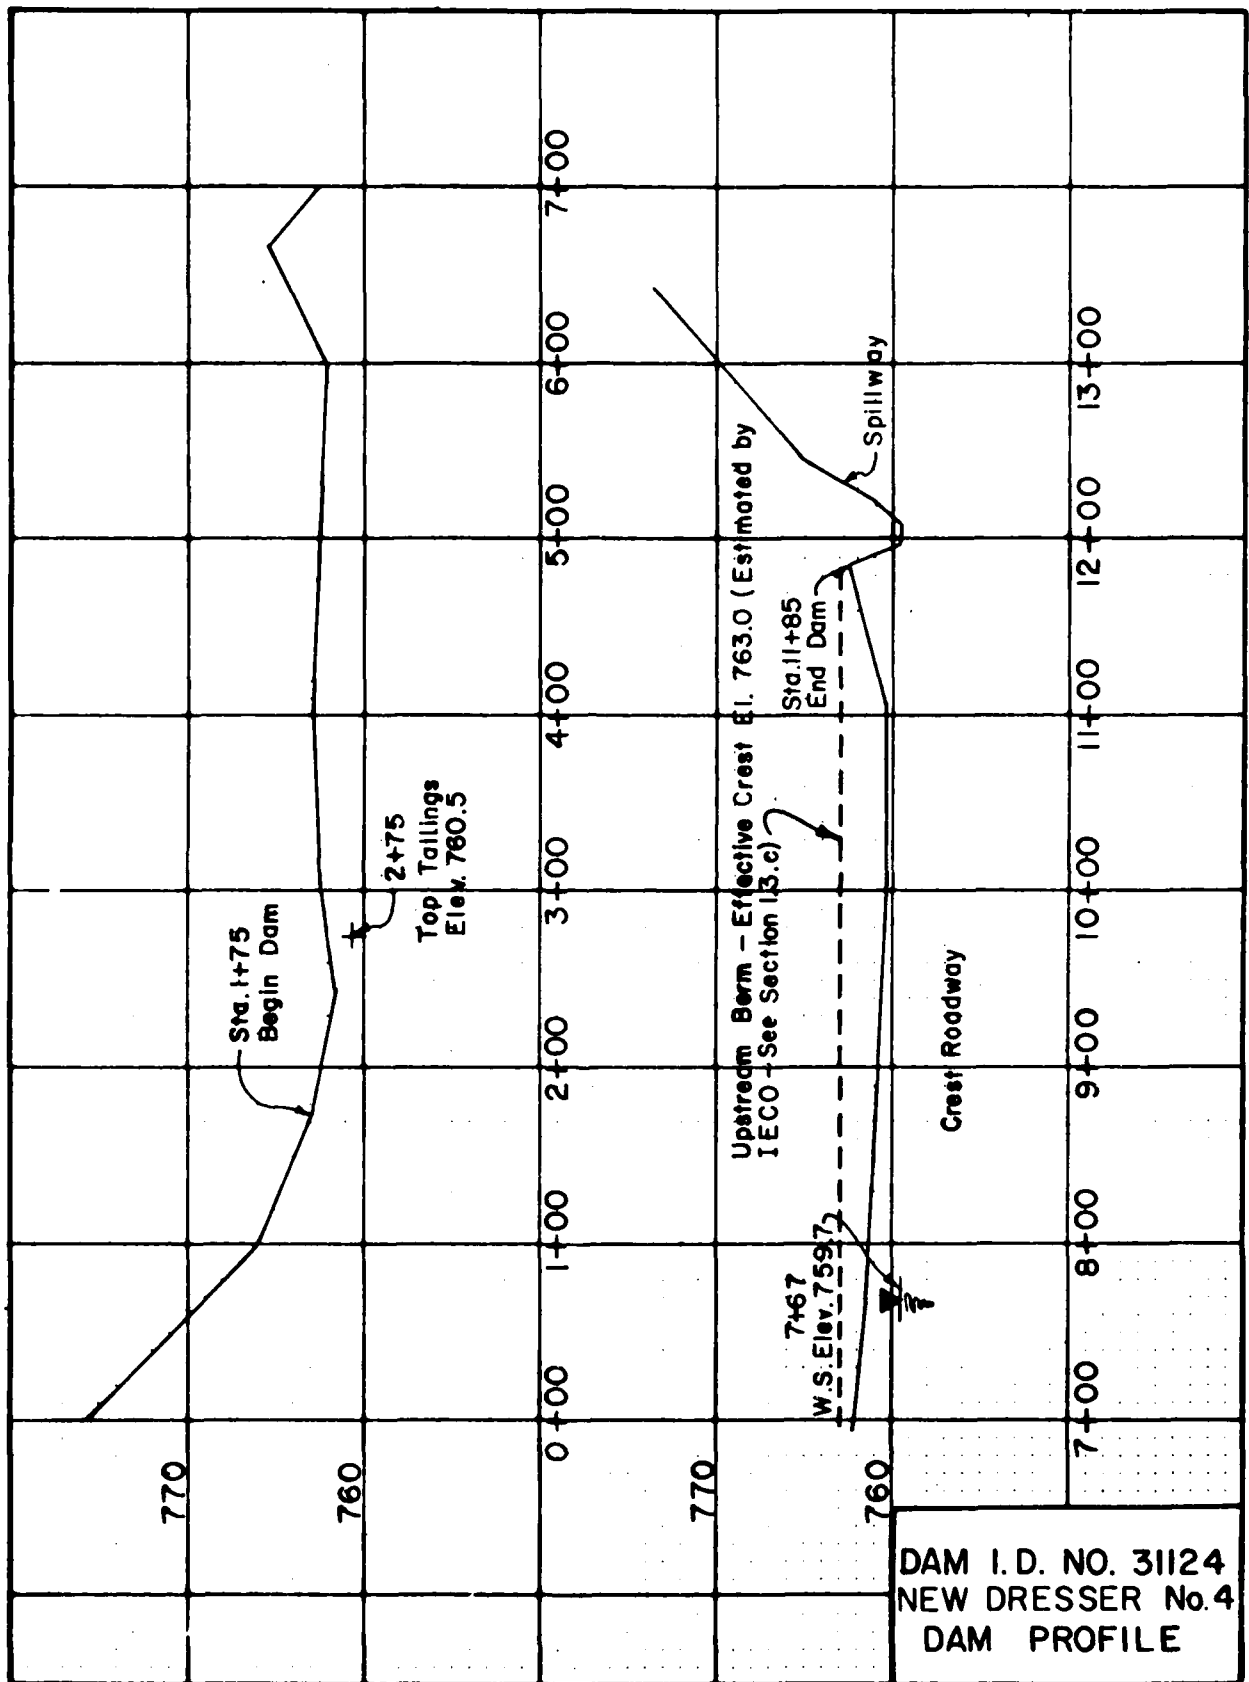
PLATE 4

- (1) Top of dam - Varies from El. 760.5 (between Stations 10+00 and 11+00) to El. 765.5 along the crest roadway (see Plate 4). Since there is a wide upstream berm approximately between Stations 7+00 and 11+85 (see Photo No. 3) which was about 3 to 4 feet higher than the crest roadway on the date of the survey, the effective crest level is at El. 763.0 along this section, as shown in Plate 4. The minimum dam crest level is at El. 762.0, at Stations 2+40 and 6+00.
- (2) Streambed downstream of toe of dam - El. 717 ±.
- (3) Spillway crest - El. 760.0.
- (4) Tailings surface adjacent to south portion of dam - El. 760.5 (on date of survey).
- (5) Water surface adjacent to north portion of dam - El. 759.7 (on date of survey).
